## Managing Gearbox Failure

S. Leske, Momac Maschinenbau GmbH & Co. KG  
D. Kitaljevich, GasTOPS Ltd.

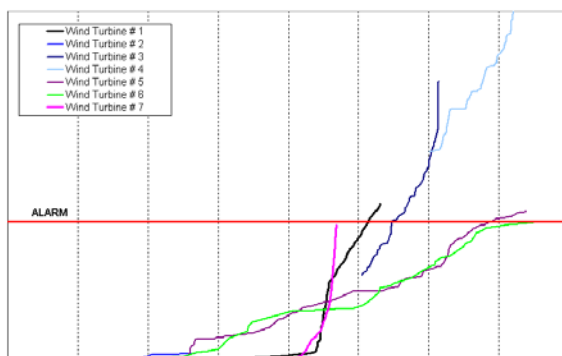
Wind Turbine Gearbox  
Damage Progression Field Results

The damage progression displayed in the case history is representative of gearbox damage events that have occurred on other wind turbines. MetalSCAN already has numerous wind turbine gearbox damage events recorded as shown below. The plot shows data for six different events where the data is normalized to the alarm limit to factor out the particle counts variation due to different gearbox models. MetalSCAN consistently provides 3 to 5 months reliable warning of progressing gearbox damage prior to risk of severe damage to the gearbox. Similar results have been achieved by GE Wind as presented at the EWEA conference in 2004 [4] and 2006 [5].
